# Forest UPDATE Certification

## Canadian Forest Products Ltd. 2016 CSA Z809/ISO 14001 Surveillance Audit Public Summary Report

Between January and August 2016 an audit team from KPMG Performance Registrar Inc. (KPMG PRI) carried out a combined CSA Z809/ISO 14001 surveillance audit of Canadian Forest Products Ltd.'s (Canfor's) B.C. and Alberta woodlands operations. This Certification Summary Report provides an overview of the audit process and KPMG's findings.

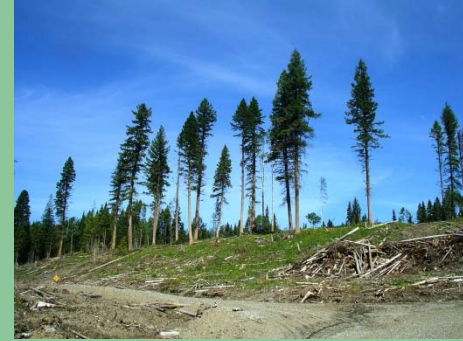
Douglas-fir is at the northern limit of its geographic distribution in a number of Canfor’s B.C. woodlands operating areas. Where encountered in these areas Douglas-fir trees are typically excluded from harvesting so they can act as a seed source.

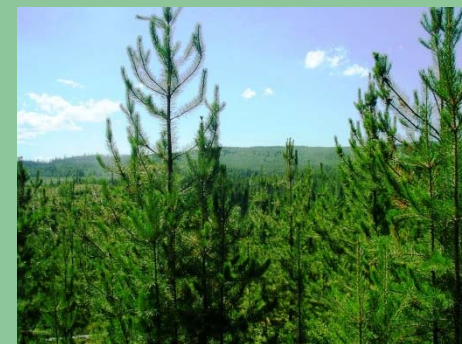
Review of 2015 Forest Management Agreement (FMA) performance survey results found that Canfor is exceeding the 5 year rolling average MAI (mean and increment) targets for both coniferous and deciduous stands. (Grande Prairie)
