Canadian Forest Products Ltd. 2017 ISO 14001 Re-certification/CSA Z809 Surveillance Audit Public Summary Report

Between February and September 2017 an audit team from KPMG Performance Registrar Inc. (KPMG PRI) carried out a combined ISO 14001 re-certification/CSA Z809 surveillance audit of Canadian Forest Products Ltd.'s (Canfor's) B.C. and Alberta woodlands operations. This Certification Summary Report provides an overview of the audit process and KPMG's findings.

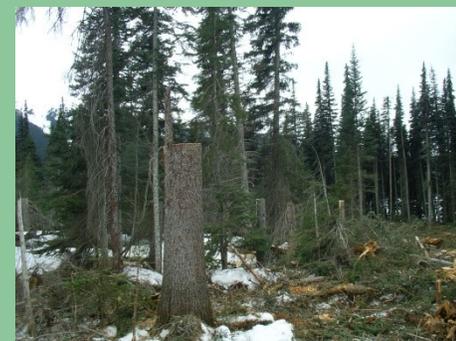
Although not formally prescribed, the audit noted several harvest blocks where non-classified drainages (NCDs) had machine free zones, stubs and understory retention applied. This practice helps reduce the potential for impacts on water quality and sensitive soils. In addition, the increased level of retention in riparian areas has a beneficial effect on stand level biodiversity. (Vavenby)

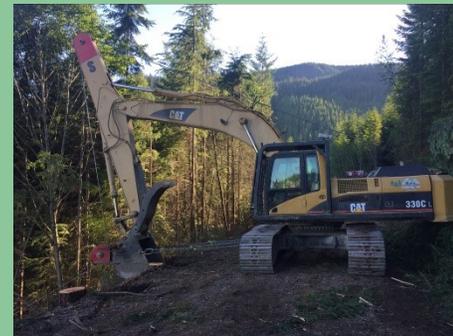
The Company is making increased use of tethered harvesting systems as a means to address the recent shift of operations into steeper ground and help ensure that they are able to harvest the full timber profile. (Corporate)

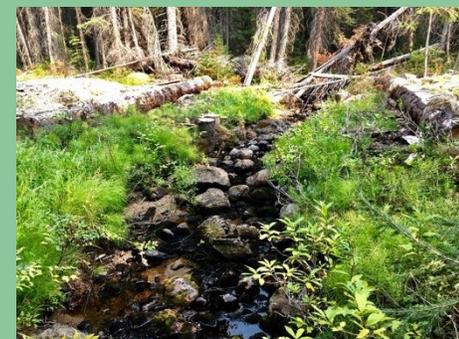
Inspection of a recent bridge deactivation project at the Company's Fort St. James operation found that the operation had done a good job of protecting the stream channel during the deactivation of the crossing.

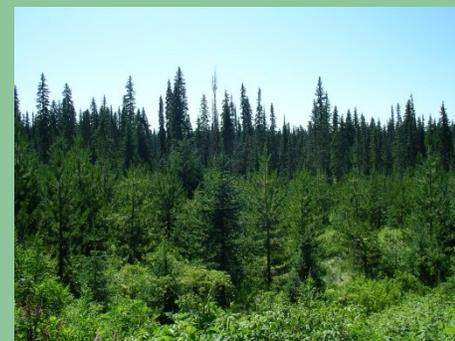
Inspection of a sample of silviculture field sites during the audit noted a high level of compliance with the reforestation requirements specified in the applicable Forest Stewardship Plan.
